**Flood Control Project Maintenance  
Levee Inspections**

**Fall 2014 Levee Maintenance Deficiency Summary Report**

**Lake County Watershed Protection District**

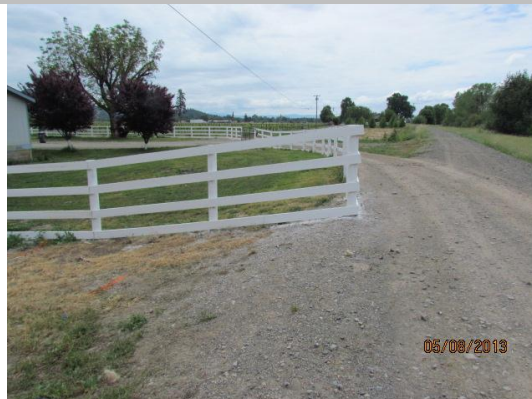
Photo 1 of 1 : FA\_2014\_NA0009\_3\_12\_20141013\_00006.jpg

LM Start	0.12	Rating **	M	Issue No.	12
LM End	0.12	Issue Type +	En	Location *	LS
Category	Earthen Levee			GPS Latitude/Longitude	
				Start	End
Item	Encroachments			39.188877 °	39.188877 °
				-122.907581 °	-122.907581 °
DWR ID	DWR_NA0009_01_s _ 2013_12				
Action/Comments					
Fence

View of the unauthorized encroachment fence along landside slope.

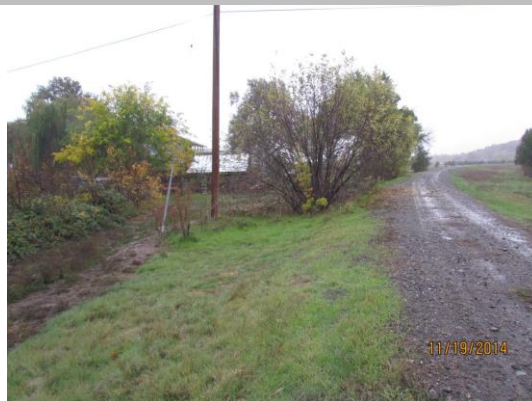
Photo 1 of 1 : FA\_2014\_NA0009\_3\_11\_20141121\_00067.jpg

LM Start	0.25	Rating **	M	Issue No.	11
LM End	0.25	Issue Type +	Ma	Location *	LS
Category	Earthen Levee			GPS Latitude/Longitude	
				Start	End
Item	Trim / Thin Trees			39.186777 °	39.186777 °
				-122.908102 °	-122.908102 °
DWR ID	DWR_NA0009_01_s _ 2013_11				
Action/Comments					
Trim and thin trees to allow visibility of the ground and room to flood fight.

Remove the trees from the landside slope.

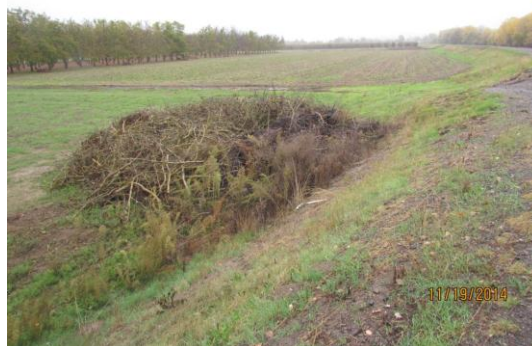
Photo 1 of 1 : FA\_2014\_NA0009\_3\_290\_20141121\_00068.jpg

LM Start	1.57	Rating **	M	Issue No.	290
LM End	1.57	Issue Type +	En	Location *	LS
Category	Earthen Levee			GPS Latitude/Longitude	
				Start	End
Item	Encroachments			39.169918 °	39.169918 °
				-122.915197 °	-122.915197 °
DWR ID	DWR_NA0009_01_f_2014_290				
Action/Comments					
Prunings

View of the prunings along the landside toe.

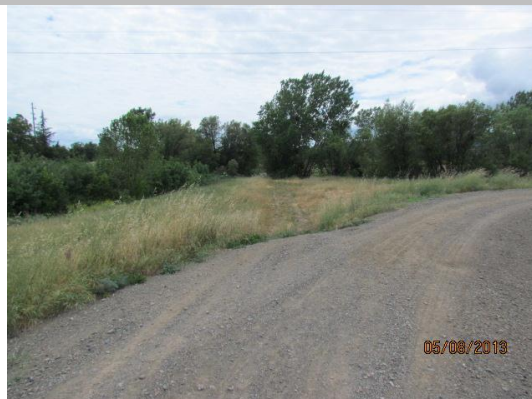
Photo 1 of 1 : FA\_2014\_NA0009\_3\_13\_20141013\_00007.jpg

LM Start	2.29	Rating **	M	Issue No.	13
LM End	2.29	Issue Type +	Ma	Location *	WS
Category	Earthen Levee			GPS Latitude/Longitude	
				Start	End
Item	Slope Stability			39.160285 °	39.160285 °
				-122.913481 °	-122.913481 °
DWR ID	DWR_NA0009_01_s_2013_13				
Action/Comments					
Repair the levee slope damaged by vehicle traffic and prevent access where possible.

View of the vehicle erosion along the waterside slope.

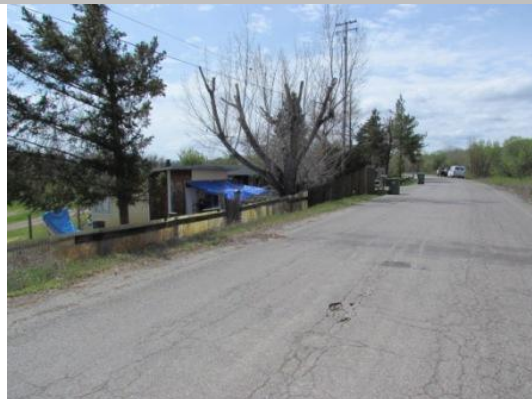
Photo 1 of 1 : FA\_2014\_NA0009\_3\_4\_20141013\_00002.jpg

LM Start	2.58	Rating **	M	Issue No.	4
LM End	2.61	Issue Type +	En	Location *	LS
Category	Earthen Levee			GPS Latitude/Longitude	
				Start	End
Item	Encroachments			39.160398 °	39.159952 °
				-122.912837 °	-122.913220 °
DWR ID	DWR_NA0009_01_s _ 2012_4				
Action/Comments					
Fence

View of the fences at the L/S toe.

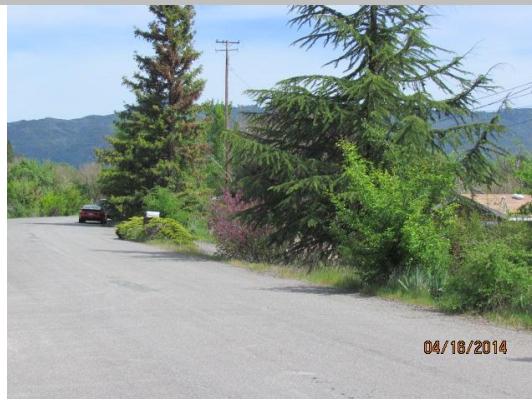
Photo 1 of 1 : FA\_2014\_NA0009\_3\_5\_20141013\_00003.jpg

LM Start	2.62	Rating **	M	Issue No.	5
LM End	2.67	Issue Type +	En	Location *	LS
Category	Earthen Levee			GPS Latitude/Longitude	
				Start	End
Item	Vegetation			39.159657 °	39.159657 °
				-122.913345 °	-122.913345 °
DWR ID	DWR_NA0009_01_s _ 2012_5				
Action/Comments					
Landscaping

View of the landscape along the landside slope.

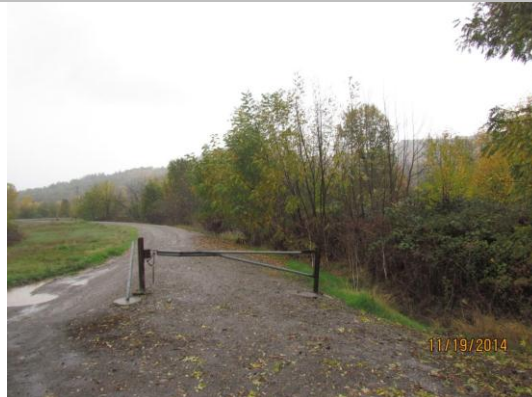
Photo 1 of 1 : FA\_2014\_NA0009\_4\_9\_20141121\_00080.jpg

LM Start	0.24	Rating **	M	Issue No.	9
LM End	0.29	Issue Type +	Ma	Location *	LS
Category	Earthen Levee			GPS Latitude/Longitude	
				Start	End
Item	Trim / Thin Trees			39.186739 °	39.186038 °
				-122.909436 °	-122.909948 °
DWR ID	DWR_NA0009_02_s_2013_9				
Action/Comments					
Thin trees to allow visibility of the ground and room to flood fight.

Trim the trees of 5 feet to allow visibility.

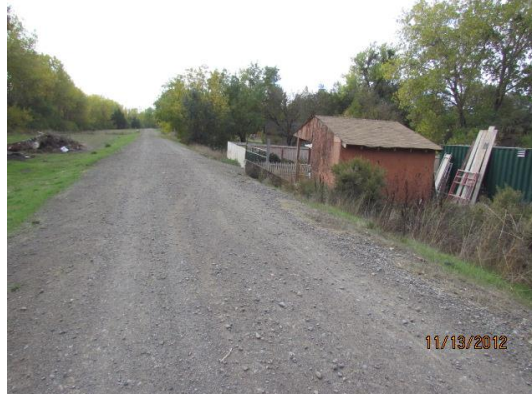
Photo 1 of 1 : FA\_2014\_NA0009\_4\_5\_20141013\_00005.jpg

LM Start	1.05	Rating **	M	Issue No.	5
LM End	1.05	Issue Type +	En	Location *	LS
Category	Earthen Levee			GPS Latitude/Longitude	
				Start	End
Item	Encroachments			39.176875 °	39.176875 °
				-122.913685 °	-122.913685 °
DWR ID	DWR_NA0009_02_s_2012_5				
Action/Comments					
Building

View of building &amp; vegetation along the levee toe.

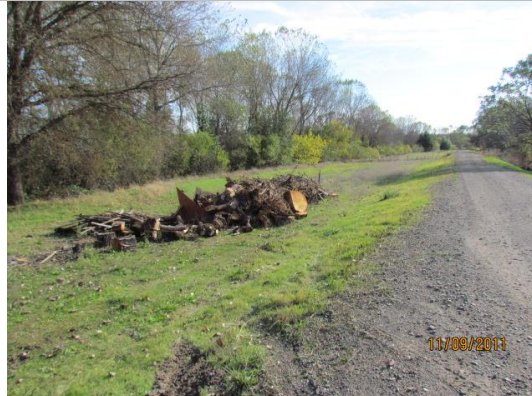
Photo 1 of 1 : FA\_2014\_NA0009\_4\_3\_20141013\_00003.jpg

LM Start	1.06	Rating **	M	Issue No.	3
LM End	1.06	Issue Type +	Ma	Location *	WS
Category	Earthen Levee			GPS Latitude/Longitude	
				Start	End
Item	Encroachments			39.176835 °	39.176835 °
				-122.913558 °	-122.913558 °
DWR ID	DWR_NA0009_02_s_2012_3				
Action/Comments					
Tree or limb

View of the tree prunings on the W/S toe.

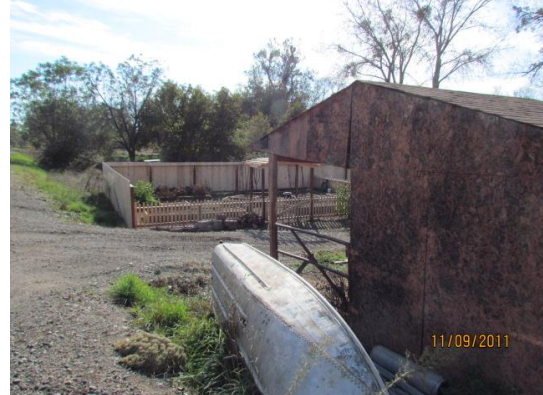
Photo 1 of 1 : FA\_2014\_NA0009\_4\_2\_20141013\_00002.jpg

LM Start	1.06	Rating **	U	Issue No.	2
LM End	1.06	Issue Type +	En	Location *	LS
Category	Earthen Levee			GPS Latitude/Longitude	
				Start	End
Item	Encroachments			39.176815 °	39.176815 °
				-122.913540 °	-122.913540 °
DWR ID	DWR_NA0009_02_s_2012_2				
Action/Comments					
Fence

View of the building &amp; fence along the L/S toe.

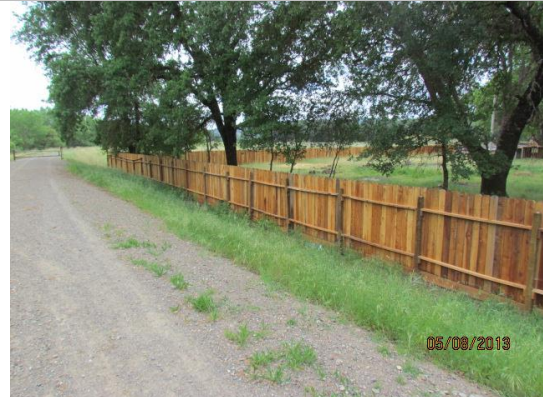
Photo 1 of 1 : FA\_2014\_NA0009\_4\_10\_20141013\_00008.jpg

LM Start	1.15	Rating **	U	Issue No.	10
LM End	1.18	Issue Type +	En	Location *	LS
Category	Earthen Levee			GPS Latitude/Longitude	
				Start	End
Item	Encroachments			39.175460 °	39.175075 °
				-122.913400 °	-122.913392 °
DWR ID	DWR_NA0009_02_s_2013_10				
Action/Comments					
Fence

View of the unauthorized fence along the landside toe.

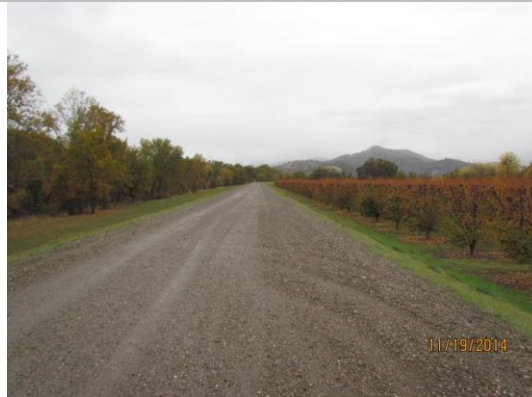
Photo 1 of 1 : FA\_2014\_NA0009\_5\_141\_20141121\_00059.jpg

LM Start	0.06	Rating **	A	Issue No.	141
LM End	0.06	Issue Type +	Ma	Location *	LS
Category	Earthen Levee			GPS Latitude/Longitude	
				Start	End
Item	Vegetation			39.148917 °	39.148917 °
				-122.914688 °	-122.914688 °
DWR ID	DWR_NA0009_03_f_2014_141				
Action/Comments					
Control annual grass and weeds on the levee slopes and easements.

View of the controled vegetation on both slopes.

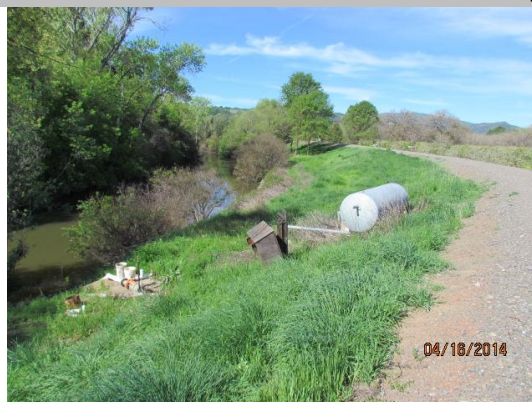
Photo 1 of 1 : FA\_2014\_NA0009\_5\_1\_20141013\_00001.jpg

LM Start	0.97	Rating **	M	Issue No.	1
LM End	0.97	Issue Type +	En	Location *	WS
Category	Earthen Levee			GPS Latitude/Longitude	
				Start	End
Item	Encroachments			39.160108 °	39.160108 °
				-122.922110 °	-122.922110 °
DWR ID	DWR_NA0009_03_s_2012_1				
Action/Comments					
Tank

View of the permitted tank on the waterside slope.

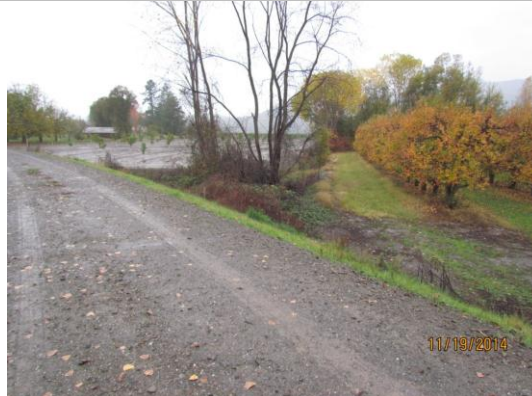
Photo 1 of 1 : FA\_2014\_NA0009\_6\_2\_20141121\_00046.jpg

LM Start	1.05	Rating **	M	Issue No.	2
LM End	1.18	Issue Type +	Ma	Location *	LS
Category	Earthen Levee			GPS Latitude/Longitude	
				Start	End
Item	Trim / Thin Trees			39.180479 °	39.181947 °
				-122.896567 °	-122.895112 °
DWR ID	DWR_NA0009_04_s_2012_2				
Action/Comments					
Trim trees to at least five feet above ground level.

Remove the trees and vegetation from the levee toe.

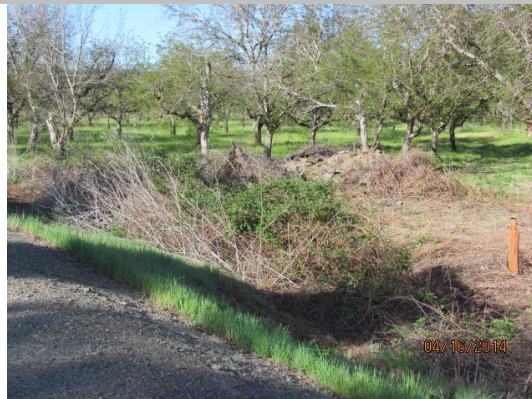
Photo 1 of 1 : FA\_2014\_NA0009\_6\_9\_20141013\_00003.jpg

LM Start	1.19	Rating **	M	Issue No.	9
LM End	1.26	Issue Type +	Ma	Location *	LS
Category	Earthen Levee			GPS Latitude/Longitude	
				Start	End
Item	Vegetation			39.182154 °	39.182951 °
				-122.895005 °	-122.894409 °
DWR ID	DWR_NA0009_04_s_2012_9				
Action/Comments					
Remove the wild growth other than native grasses from the levee slopes.

View of the vegetation growing at the toe.

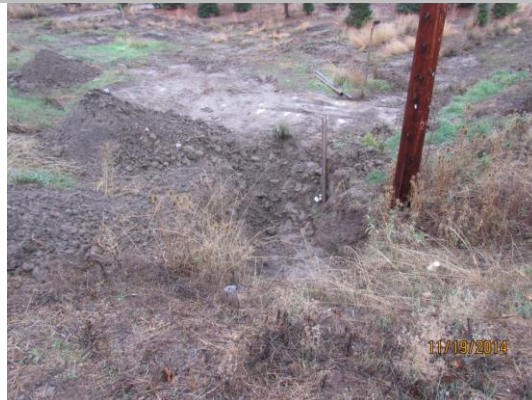
Photo 1 of 1 : FA\_2014\_NA0009\_7\_69\_20141121\_00020.jpg

LM Start	0.54	Rating **	U	Issue No.	69
LM End	0.54	Issue Type +	Ma	Location *	LS
Category	Earthen Levee			GPS Latitude/Longitude	
				Start	End
Item	Slope Stability			39.175752 °	39.175752 °
				-122.902737 °	-122.902737 °
DWR ID	DWR_NA0009_05_f_2014_69				
Action/Comments					
Repair slope instability. Inspector Comments: A property owner was digging in the levee and Lake County is going to contact me when the levee slope is being backfilled.

The property owner was digging up a water line in the slope of the levee.
